Maintenance Actions to Address Fatigue Cracking in Steel Bridge Structures

PROPOSED GUIDELINES AND COMMENTARY

NCHRP Transportation Research Board of
The National Academies

Robert J. Connor and Jason B. Lloyd
Purdue University
West Lafayette, Indiana

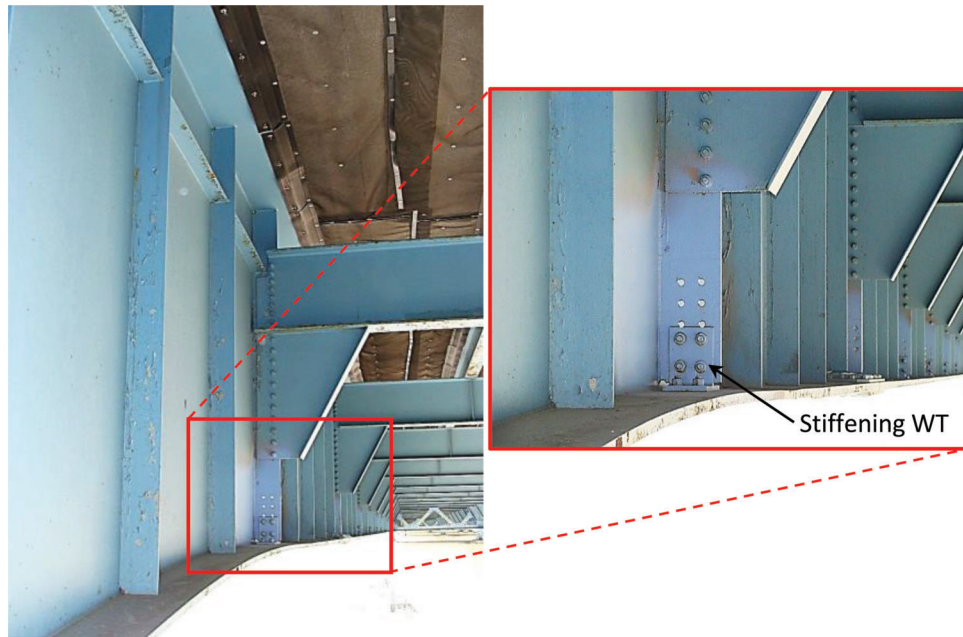
Figure 6.9 WT stiffening retrofit implemented on the Hoan Bridge.

Fish *et al.* (2015) recommended use of a WT shape for stiffening web gaps over hot rolled angles because the section properties for the WT can provide for a stiffer connection. They suggested a WT section such as WT13.5x89, but have also observed a section like a WT12x52 perform successfully on the I-64 Kanawha River Bridge in Dunbar, West Virginia, with reference to Connor and Fisher (2001). The section properties of the WT12x52 are also consistent with the minimum section recommended by Bowman *et al.* (2012). See Figure 6.7 and Figure 6.8 for an illustration of this retrofit. Figure 6.9 shows a WT stiffening retrofit that was implemented as part of the Hoan Bridge repairs discussed more in Section 7.1 of this guideline.

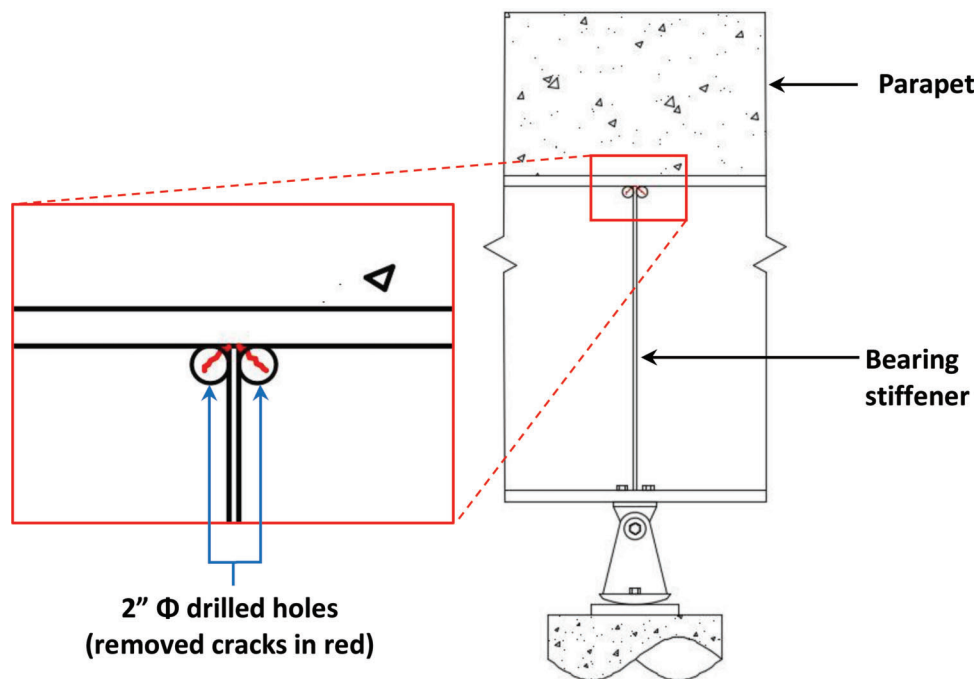
Figure 6.10 Drilled hole prototype installed at bearing stiffeners (Reproduced from Koob *et al.*, 1985).

Koob *et al.* (1985) investigated a large-hole retrofit as an economical way to remove or intercept any existing cracks near the top flange at bearing stiffener-to-floor-beam connections. The prototype retrofit was installed in three locations on the Poplar Street Bridge Approaches, near St. Louis, to determine if the out-of-plane stiffness of the connection would change and to measure the stress range along the weld toe adjacent to the drilled holes. Figure 6.10 shows the basic detail used. They drilled 2 inch diameter holes on either side of the stiffener connection plate, intercepting the flange-to-web weld toe and bearing stiffener-to-web weld toes by 1/8 inch. Intercepting the weld toes in this way prevents a fatigue crack from propagating along the weld toe without being arrested in the retrofit holes. Results from the field test showed that the retrofit was effective in reducing the distortion-induced stress ranges to 6.6 ksi or less, which is less than the Category C CAFL determined for a typical quality drilled hole (Brown *et al.*, 2007; Fisher *et al.*, 1987). The actual fatigue resistance will depend on the quality of the finished hole. A larger diameter hole would further reduce the stress range by increasing the connection compliance.

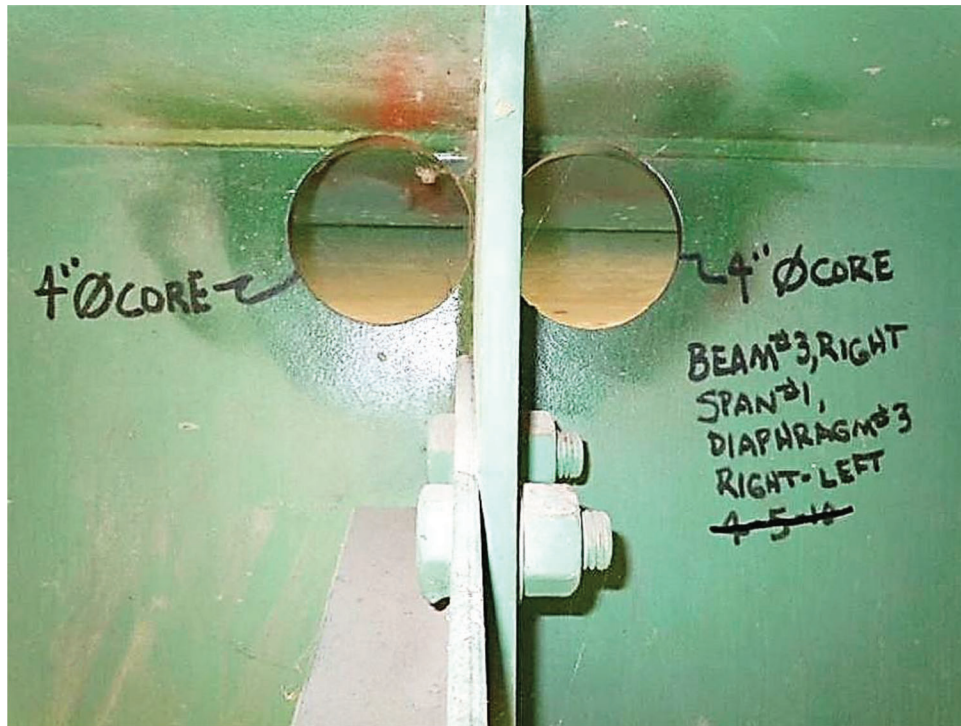
Figure 6.11 Large-hole retrofit – note interception of horizontal and vertical weld toes (Photograph courtesy of Iowa DOT).

This retrofit should be installed using techniques discussed in Section 4.3. The drilled holes are recommended to be at least 3 to 4 inches in diameter and each hole should intersect the horizontal and transverse welds approximately 1/8 inch. If a hole misses either of the welds, use a die grinder and carbide rotary burr bit to grind from the inside of the drilled hole toward the missed weld until the hole is extended sufficiently to intercept it. Maintain a round and gradual profile as best as possible. In the case that there is an existing

crack at the detail, the hole should be drilled to either completely remove the crack, or if the crack is too long to be completely removed, the hole should be drilled such that it removes the crack tip. See Figure 4.4 for recommendations on hole placement. This may require that the drilled hole be placed such that the horizontal flange-to-web weld is missed. If this is the case, it is recommended that grinding or an additional hole be used to ensure the horizontal weld toe is intercepted to isolate the web plate from crack propagation.

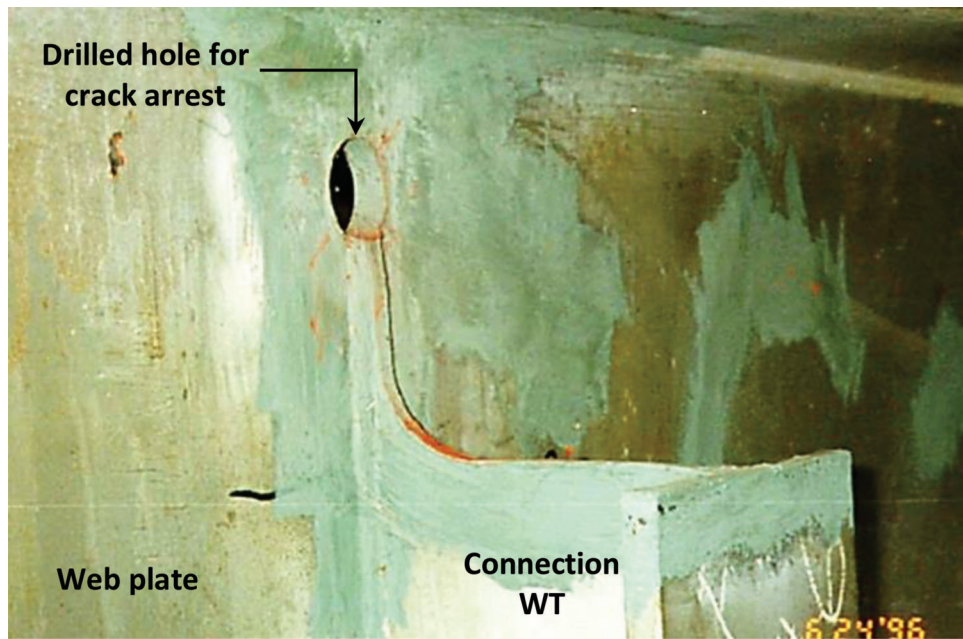
Figure 6.12 Lexington Ave Bridge cutback retrofit (Photograph courtesy of MNDOT).

the web and it was decided that it could be left in place. Shortly after the retrofits were completed, fatigue cracks were found initiating at the end of the remaining weld. The bridge owner had a drilled hole added to the details later to remove the weld terminations and cracks, as see in Figure 6.12.

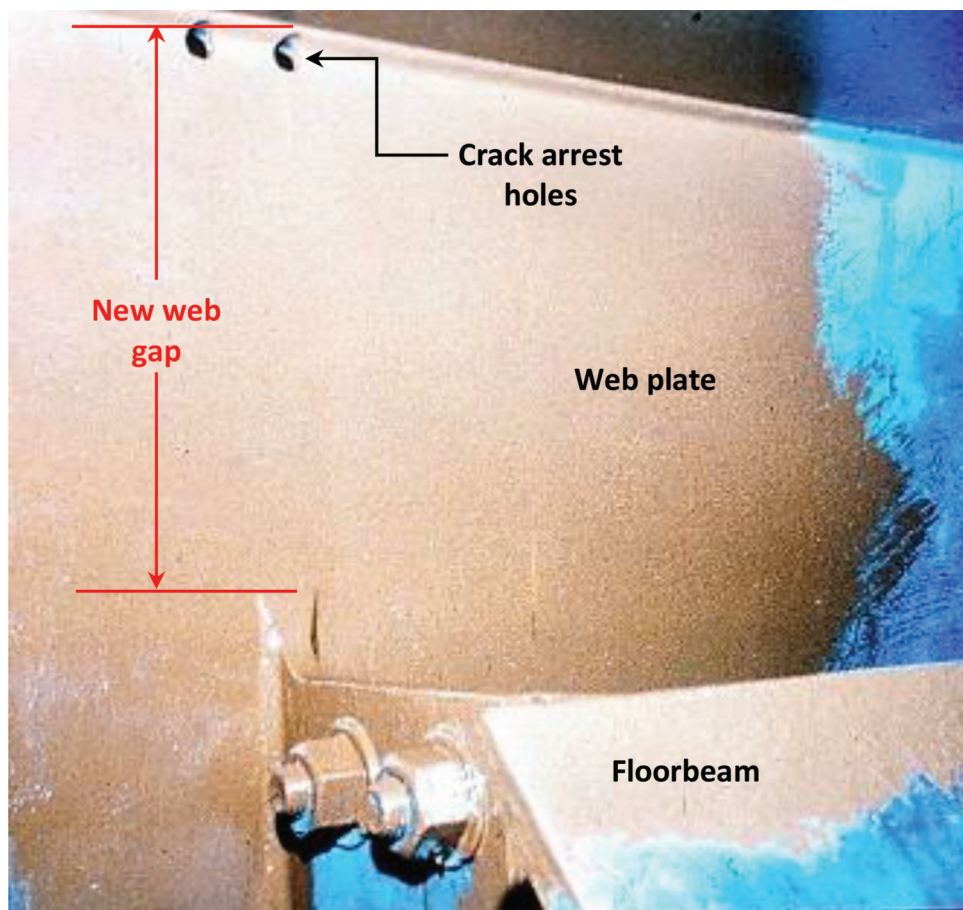
Figure 6.13 Cutback retrofit installed on Polk County Bridge (Photograph courtesy of Iowa DOT).

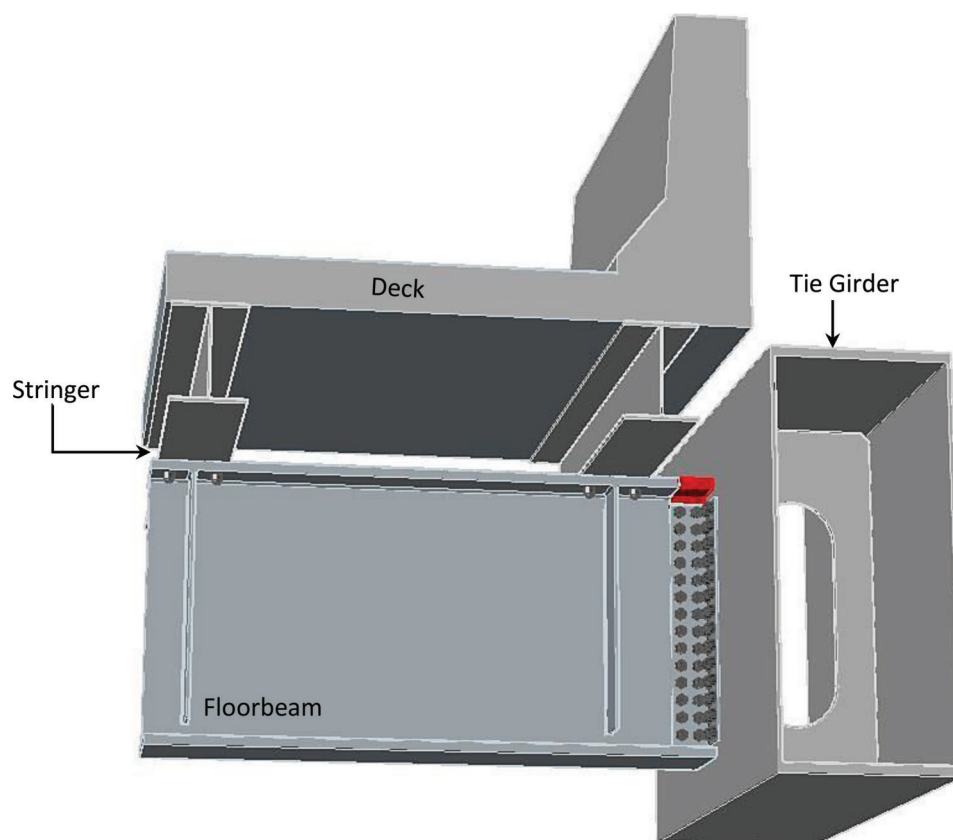
Figure 6.14 Illustration highlighting in red the area of a floorbeam web prone to web gap cracks.

The driving mechanism for distortion-induced fatigue in the web plate of secondary members, such as floorbeams or cantilever brackets, is illustrated in Figure 6.14.

The red area highlighted on the floorbeam at the top of the connection to the tie girder is the location where the cracking is most often seen. Note, however, that distortion-induced fatigue cracks have also been observed at the web gap that sometimes exists between the transverse stiffeners on the floorbeam directly beneath the stringers when the stiffener is not attached to the floorbeam flange (Albrecht & Wright, 2000). Use Section 6.1 for retrofit and repair of these areas.

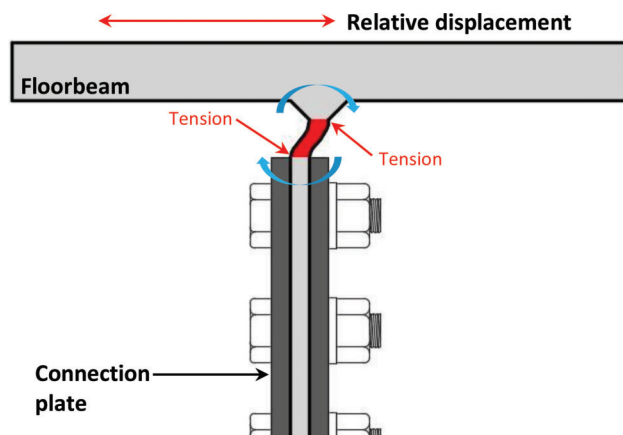
Figure 6.15 Cross section illustrating driving stresses for the floorbeam web gap cracking.

A cross section of the floorbeam-tie girder connection is shown in Figure 6.15. A relative displacement between the floorbeam top flange (which is connected to the stringers) and the connection plates (which are connected to the tie or primary girder) occurs. This

results in a bending of the floorbeam web plate within the small web gap area, similar to that shown in Figure 6.2 for transverse connection plates (within the web gap region, the two modes of fatigue cracking are identical). Very large tensile stresses result at the top and bottom of the web gap often causing cracks at both of these locations. Typically, this type of fatigue crack will be most prevalent in locations of largest global shear stress where the incompatibility between the floor system and tie girders will be the highest. An example of the fatigue cracks are shown in Figure 6.16 on the Birmingham tied-arch bridge over the Monongahela River in Pittsburgh, PA.

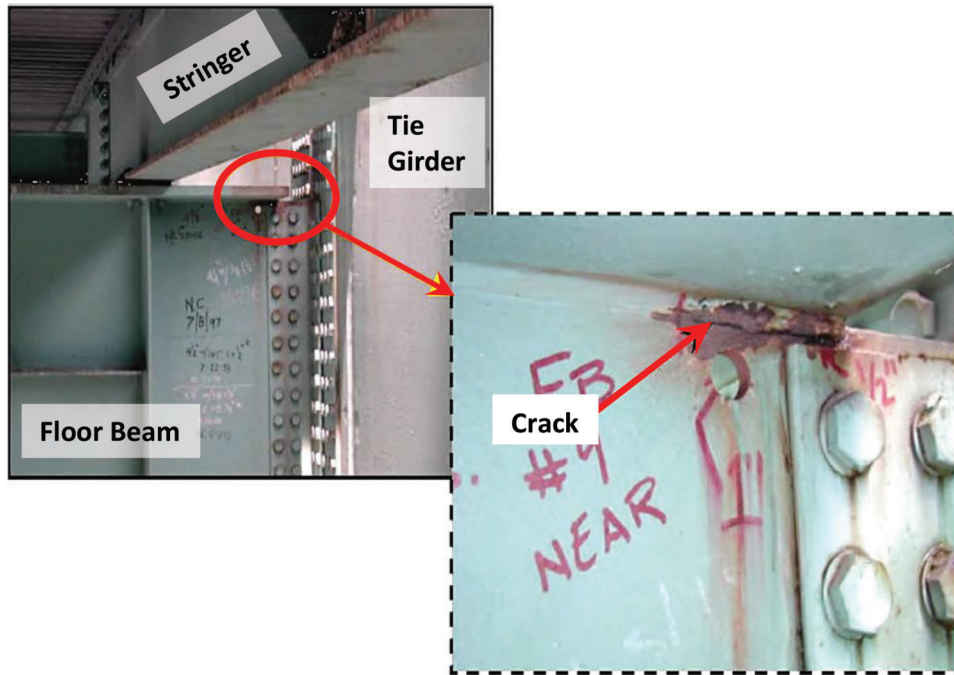
Figure 6.16 Example of distortion-induced cracking in web gap of floorbeam connected to tie girder.

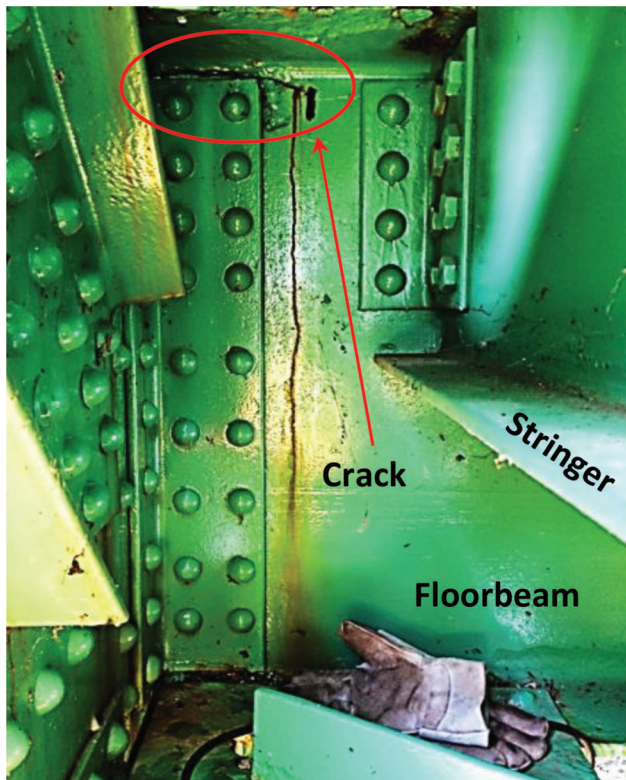
Figure 6.17 Floorbeam web gap crack.

6.2.2.1 Drilled Hole for Crack Arrest. The simplest and most economical repair is a large drilled hole for crack arrest. The reader is referred to Section 6.1.2.1 on use of drilled holes for repair and retrofit of web gap regions for transverse connection plates. An example of this repair method is shown in Figure 6.17 through Figure 6.20. These images are from the SR 119 through-truss bridge in Indiana. The end floorbeams of the simple span truss were experiencing distortion-induced fatigue cracks in the web gap region between the floorbeam top flanges and the connection angles which tied the floorbeam to the truss gusset plate. Figure 6.17 shows one of the cracks with corrosion staining. Notice how the crack initiates inside the web gap at the end of the floorbeam and extends parallel to the direction of the floorbeam primary stress (perpendicular to flow of traffic). This is an important attribute of distortion-induced fatigue that is driven by secondary stresses not normally accounted for in the design. It is also important to realize that the cracking was only manifest on the end floorbeams, where the global shear incompatibility between the floor system and the very stiff truss would be the greatest. Figure 6.18 shows the crack enhanced with dye penetrant, which was used to reveal the crack tip before drilling the hole. Figure 6.19 shows the completion of the drilled hole, prior to finishing sanding to clean up the edges for improved fatigue resistance. A 2-1/2 inch diameter hole was drilled, which when combined with the length of the crack will provide improved compliance at the detail and further relieve the secondary stresses while blunting the crack tip. Figure 6.20 shows the final step of the repair with the application of zinc-rich paint to protect against corrosion on the exposed steel. Refer to Section 4.2 for guidelines and tips for drilling effective crack arrest holes.

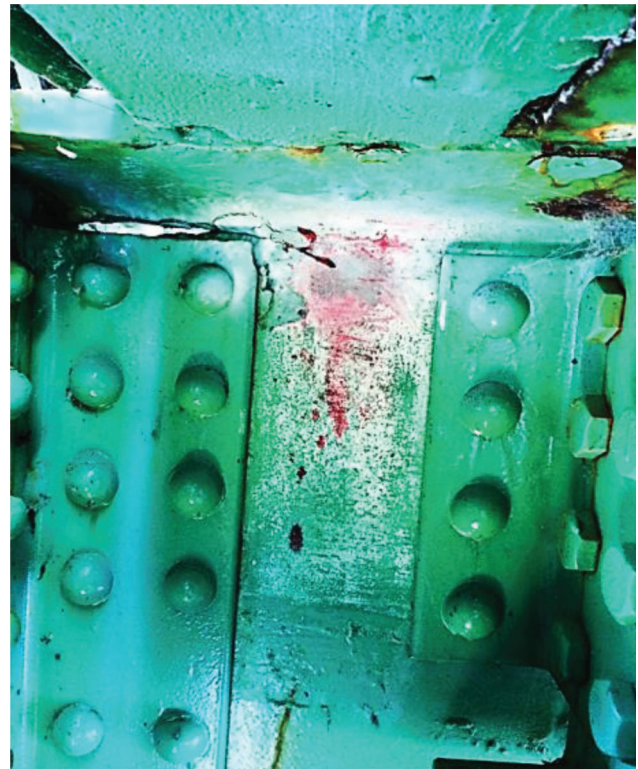
Figure 6.18 Results of PT revealing extent of crack.

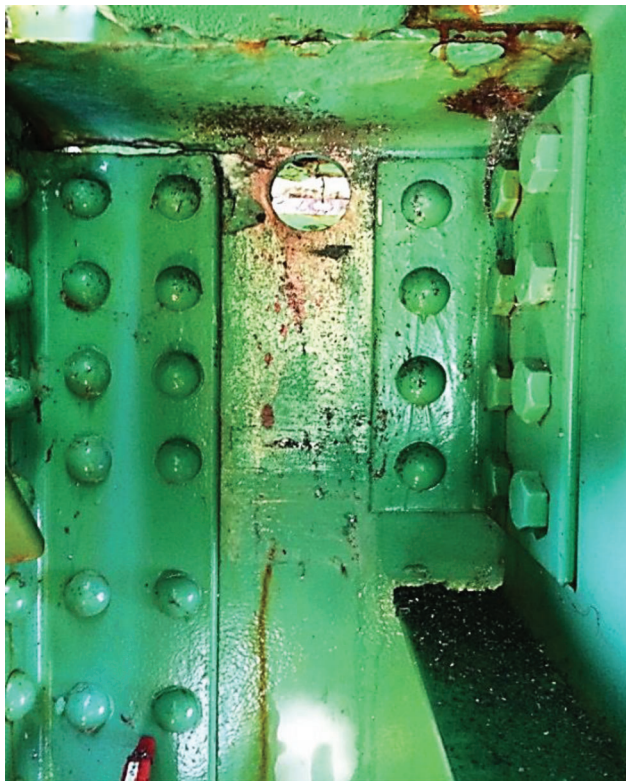
Figure 6.19 Drilled hole prior to sanding edges.

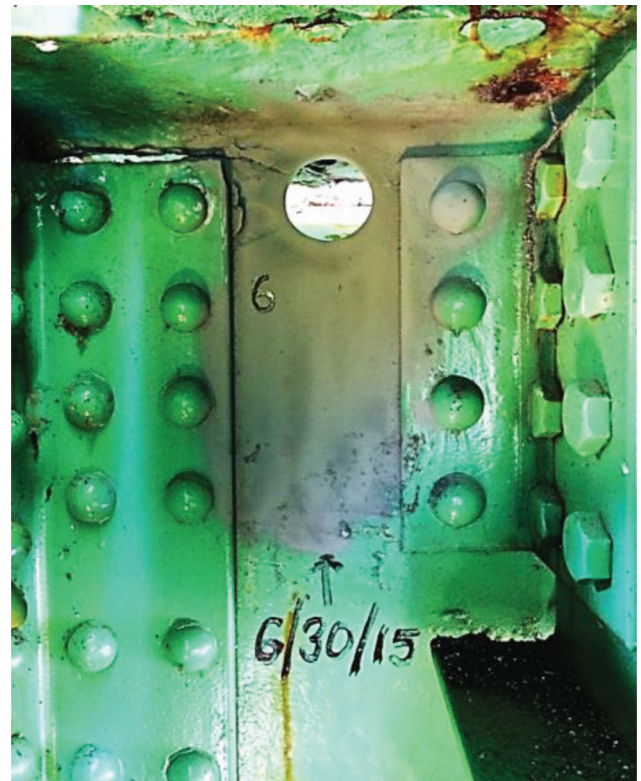
Figure 6.20 Finished repair with zinc-rich paint.

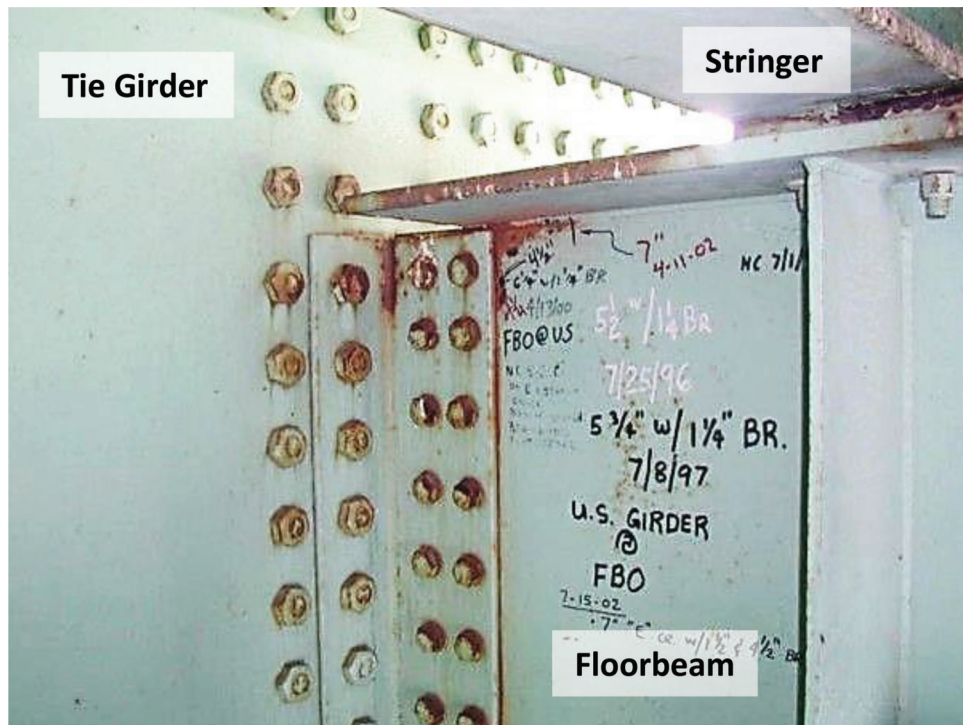
Figure 6.21 Birmingham Bridge before retrofit showing web gap cracking.

Cutting back the floorbeam connection to the primary girder has been demonstrated through prototyping (including field testing and finite element analysis) to be a very effective retrofit method and would be much less costly than a stiffening approach. Pennsylvania DOT and Lehigh University carried out a study of a prototype retrofit on the Birmingham tied-arch bridge over the Monongahela River near Pittsburgh, PA. Fatigue cracks were located on a number of the floorbeam webs near the connection to the tie girder. Field monitoring revealed that the top flanges of the floorbeams were moving out-of-plane (parallel to traffic) during traffic loading. Figure 6.21 shows the detail before retrofitting. Notice the crack extending from the floorbeam web gap above the connection angles (highlighted by corrosion staining) and positive

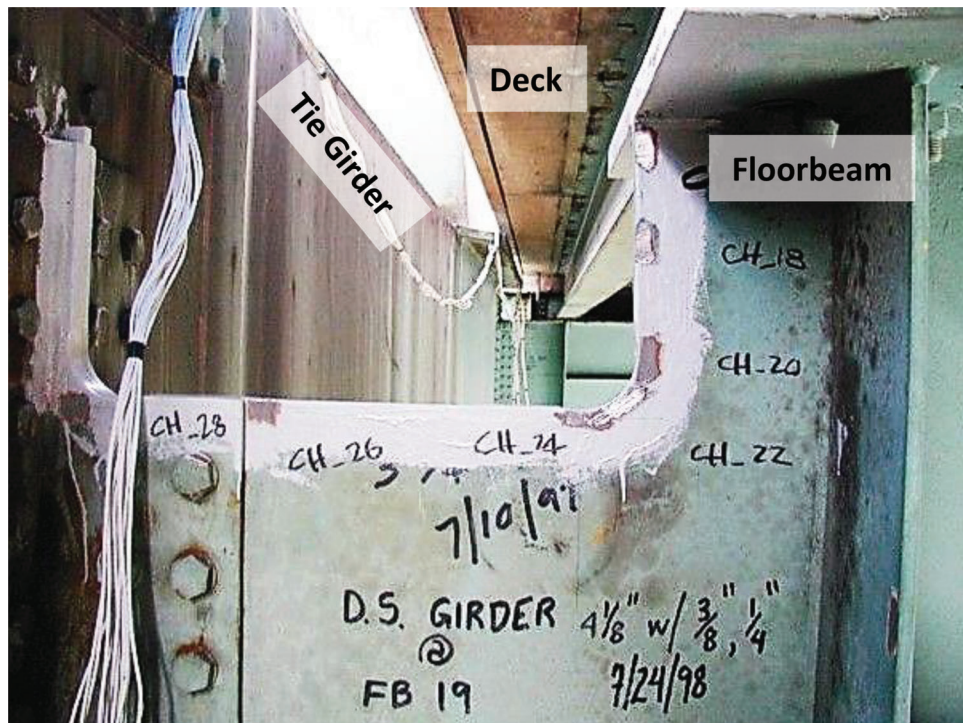
Figure 6.22 Birmingham Bridge softening retrofit that cut back the floorbeam.

attachment of the stringer to the floorbeam. The attachment to the stringer facilitates the out-of-plane movement of the floorbeam top flange as the floor system deflects independently of the tie girder. After removing the top six bolts in the connection angles and cutting out the floorbeam flange, web material, and connection angles seen removed in Figure 6.22, vertical stress ranges in the floorbeam web (those which drive the cracking) were reduced to less than the constant amplitude fatigue limit, meaning infinite fatigue life for the detail.

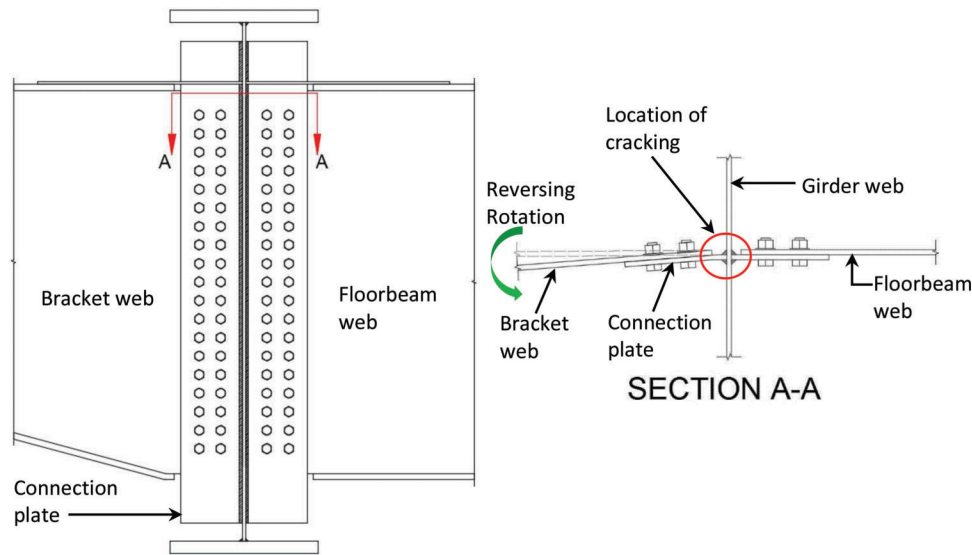
Figure 6.23 Sketch illustrating mechanism driving fatigue cracking of bracket connection plates.

Displacement incompatibility discussed in previous sections for floorbeam web gaps can also cause fatigue cracks in the connection angles and cantilever bracket webs. In the same way that a relative longitudinal displacement between the primary girder and the floor system can crack the floorbeam web near the floorbeam-girder connection, cantilevered brackets can develop cracks in the same location, as well as in their connection plates. Figure 6.23 illustrates the mechanism behind the fatigue cracking. During truck loading, compressive bending strains are developed in the primary girder top flange between the abutment and mid-span. The very stiff floor system (deck and stringers) restrains the top flange of the bracket while being displaced by the girder at the connection. This produces a relative longitudinal

displacement between the floor bracket and the primary girder, forcing bending stresses into the bracket web and connection. Similarly, this secondary action from the floor system acting on the bracket top flange can cause w-

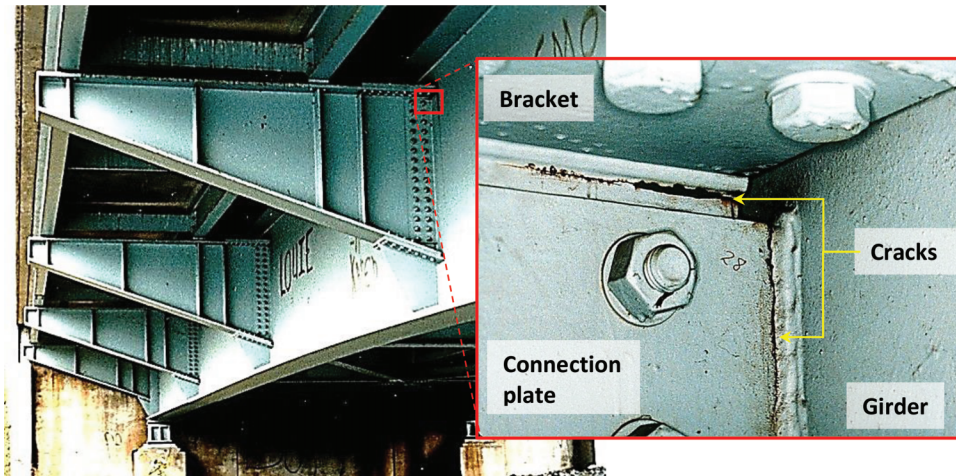
Figure 6.24 Cantilever floorbeam web gap and connection plate cracks.

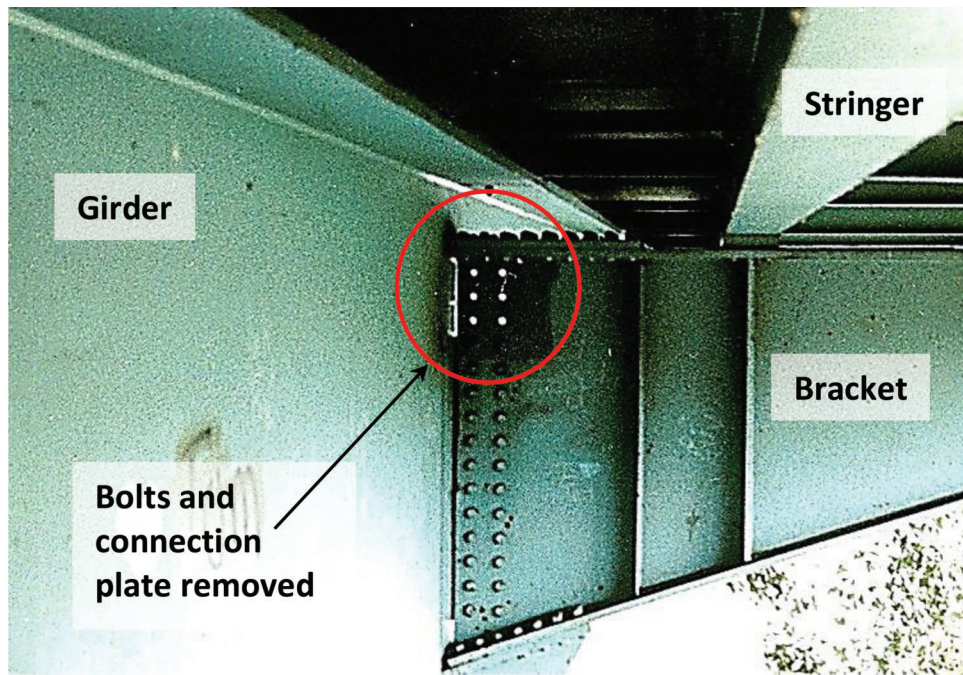
Figure 6.25 Softening retrofit on floor bracket connection plates showing removal of bolts and plate (Demers & Fisher, 1990).

The most economical and equally effective retrofit strategy for floor bracket connection plates is to soften the detail. Like the other fatigue problems caused by the global displacement incompatibility, stiffening against the global behavior at a local detail would require the addition of heavy structural sections. This can become very costly when implemented bridge-wide. Softening the detail has been implemented successfully by removing top rows of fasteners, drilling a hole through the connection plate just above the last row removed, and then cutting the upper, unconnected portion of the connection plate out of the connection. Figure 6.25 shows a softening retrofit that was installed on a floor bracket connection plate on the I-84 bridge over the Housatonic River in Connecticut (Demers & Fisher, 1990). Daylight can be seen shining through the locations where bolts were removed and the top portion

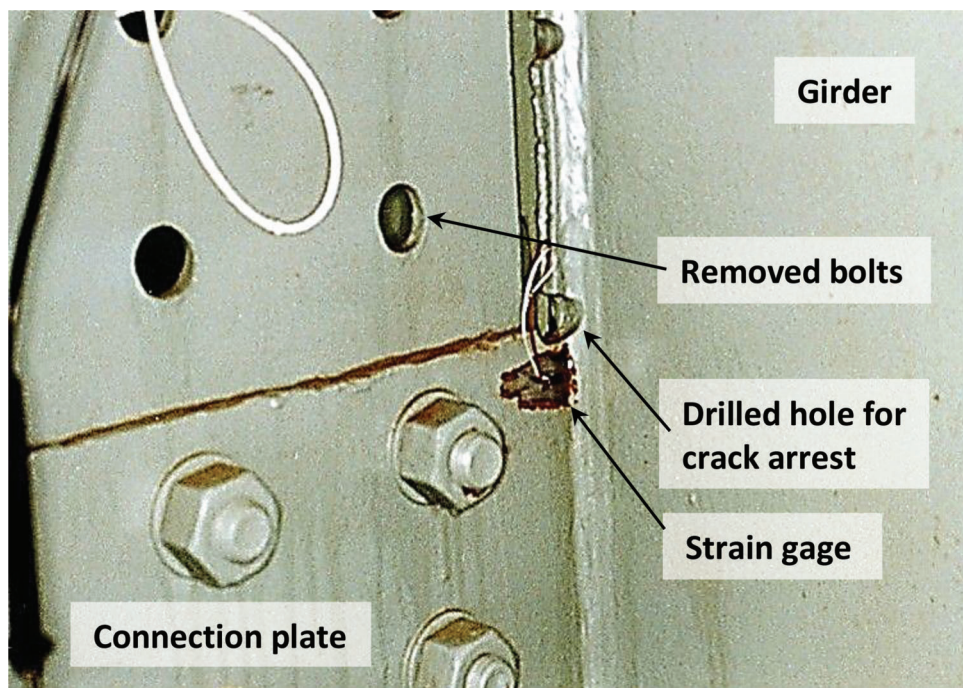
Figure 6.26 Close up showing softening detail with crack arrest hole (Demers & Fisher, 1990).

of the connection plate was cut off. Figure 6.26 shows a closer view from the opposite side where it can be seen that the fatigue crack had extended vertically along the transverse connection plate-girder web weld. A drilled hole was used to arrest the crack and the top portion of the plate was removed. The photo also shows strain gages being used for field monitoring of the live load stresses to ensure that the retrofit has sufficiently reduced the stress ranges in order to mitigate fatigue crack growth. This approach would be highly recommended for these details since each bridge will respond to live load differently and each detail may need slightly more or less softening in order to achieve the necessary stress range reduction. The monitoring could be installed very economically at one or two retrofit locations and then compared to similar locations on the bridge that have not been retrofit.

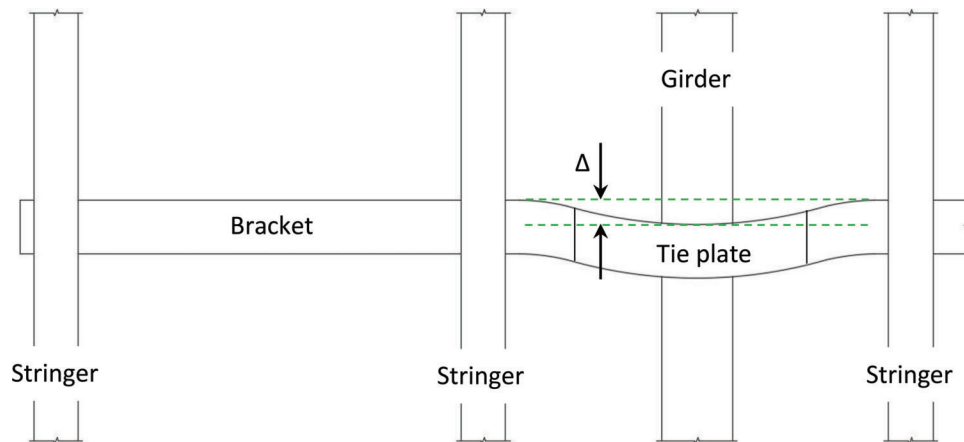
Figure 6.27 Illustration of cantilever tie plate distortion.

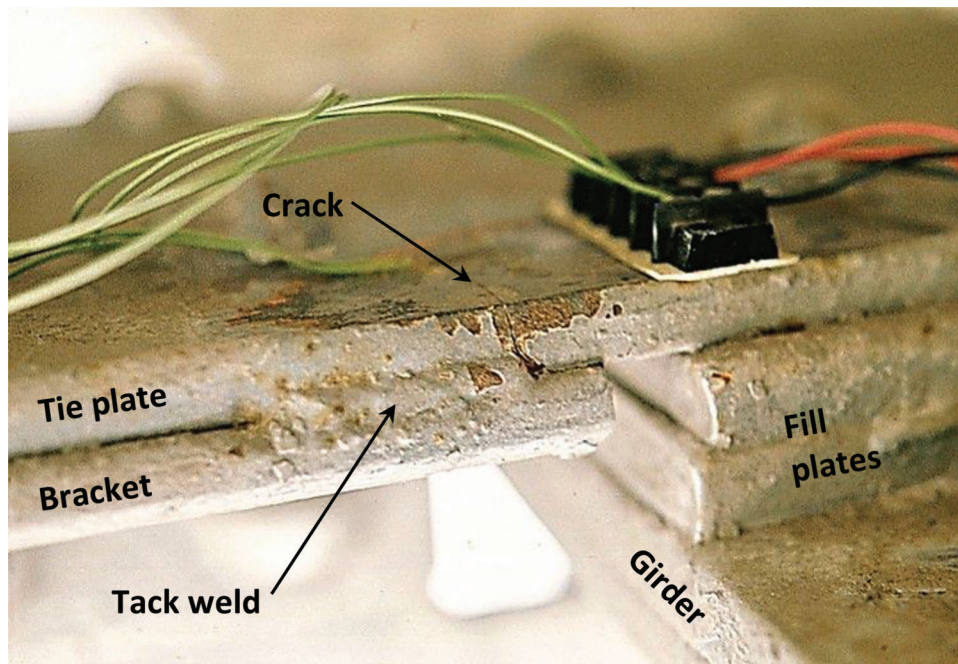
Figure 6.28 Fatigue crack emanating from tack weld on a tie plate (Photograph courtesy of John Fisher).

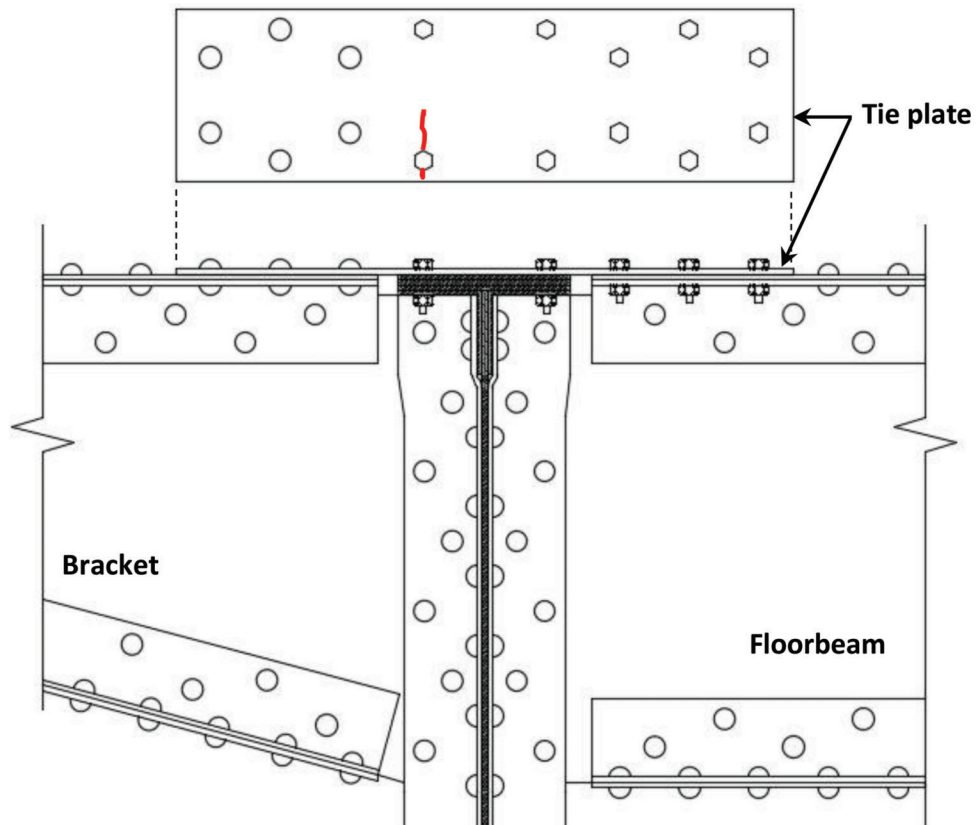
Figure 6.29 Typical tie plate detail prior to retrofit with common crack location highlighted.

Figure 6.29 shows a typical section cut at a tie plate detail with a built-up riveted main girder and a riveted and bolted connection between the tie plate and floorbeam and bracket. This figure also illustrates a typical 10 inch wide tie plate in plan-view, with a common fatigue crack location drawn in red. A redesigned tie plate cross section with reduced center width is shown in Figure 6.30.

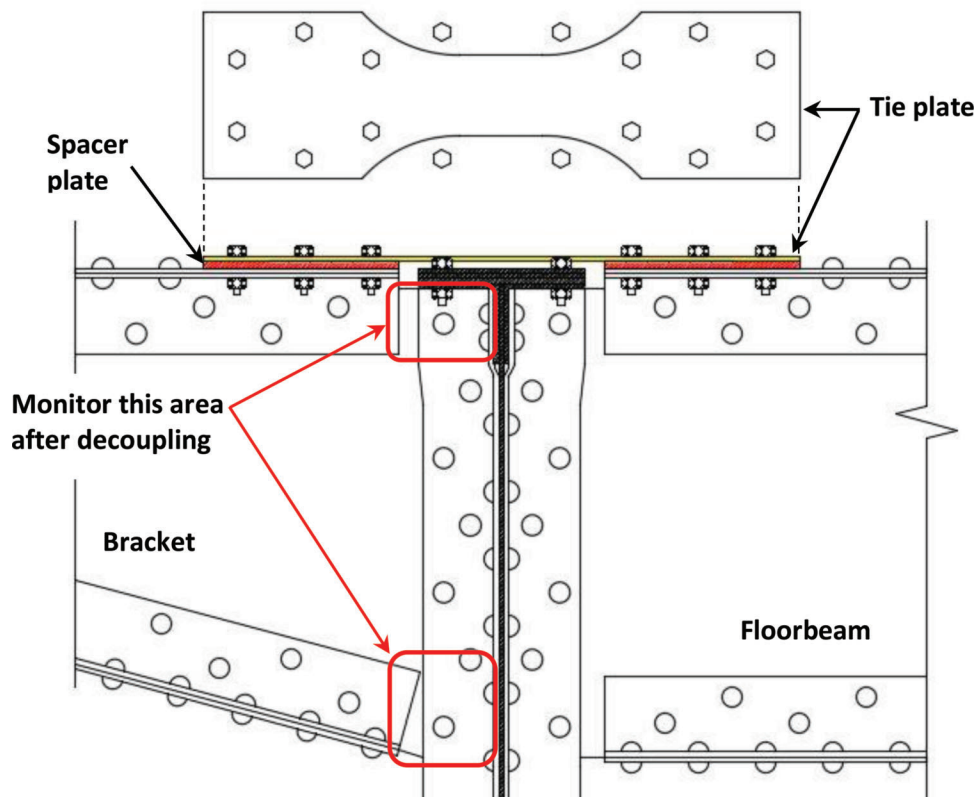
Figure 6.30 Tie plate retrofit showing reduced plate width and decoupling from girder.

unbolted to the main girder and using spacer plates at the floor bracket and floorbeam creating a gap between the tie plate and main girder. This complete retrofit is shown in Figure 6.30 where the new tie plates are highlighted in yellow and the spacer plates are highlighted in red.

Note: The web gap region with highest potential for a new fatigue problem in the floor bracket web has been circled in Figure 6.30. This area is recommended for monitoring during the prototype phase of the retrofit in addition to the tie plate itself.

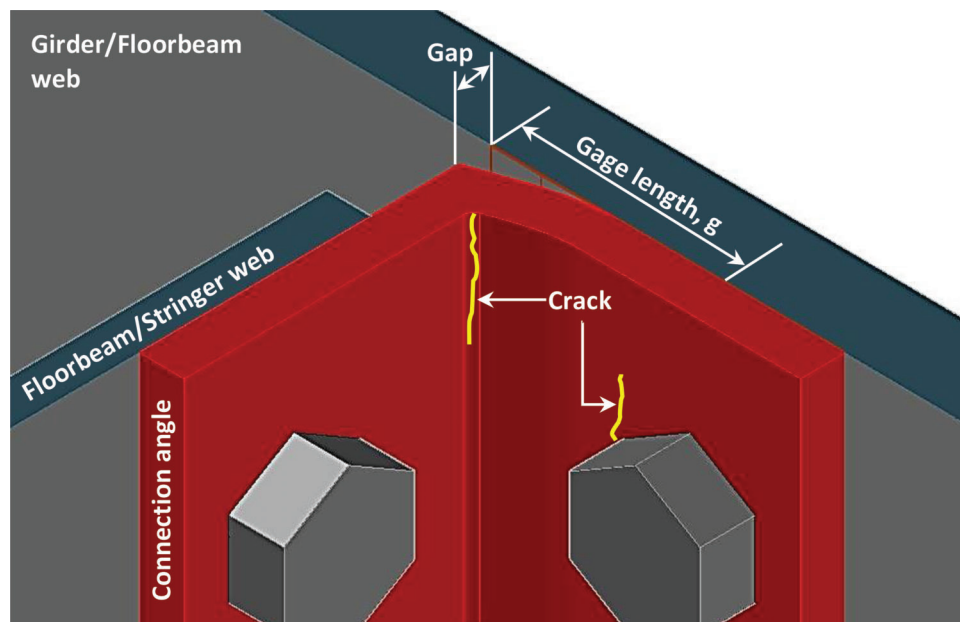
Figure 6.31 Common locations for fatigue cracks in connection angles.

Inspection of connections using angles should focus at the top or bottom of the angles in the fillet and at the edge of the fasteners, as indicated in Figure 6.31. Diaphragm connection angles prone to fatigue cracking could be located anywhere on the structure, but may be focused between interior and exterior girder lines. For stringer end connections, the most likely cases will be located at the interior stringers and at exterior floorbeams (stringers located toward the ends of spans). These locations typically experience the largest secondary effects from relative global displacements.

where g is the gage of the outstanding leg of the angle (shown in Figure 6.31), L is the length of the floorbeam, stringer or diaphragm, t is the thickness of the angle, and K is a constant, $K = 8$. This equation was used to determine the maximum angle leg thickness to ensure sufficient compliance and mitigate fatigue cracks.

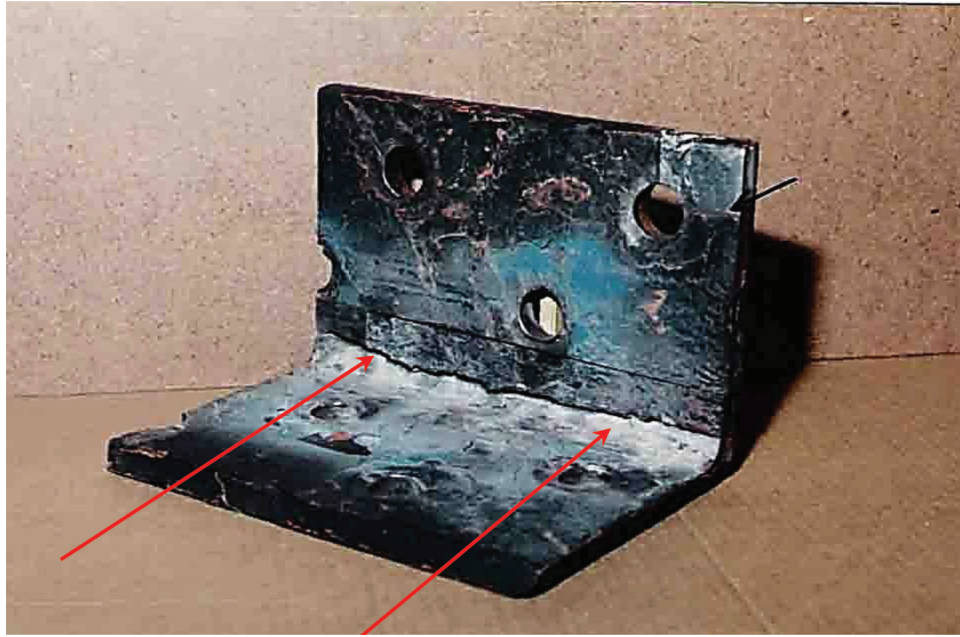
Figure 6.32 Cracked connection angle fillet (Photograph courtesy of John Fisher).

two locations. Figure 6.32 shows a stringer connection angle removed from the Burlington Northern Railroad Bridge 196.0 in Bismarck, North Dakota. Several such connection angles were found by inspectors with cracks ranging from 4 to 27 inches in length. Fractographic examination revealed fatigue and fracture surfaces (Steel Bridge Fatigue Knowledge Base, 2008). Another example of connection angle cracking is shown in Figure 6.33 taken from the Mexican Hat Bridge in Utah. These are two of many bridges where connection angles have experienced fatigue cracking.

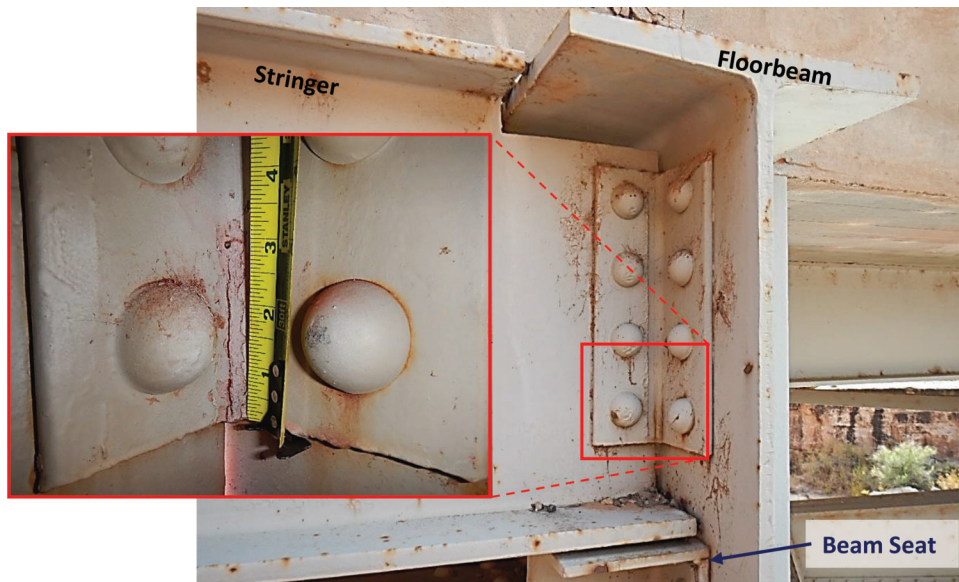
Figure 6.33 Example of fatigue crack located at the bend of a connection angle (Photograph courtesy of Utah DOT).

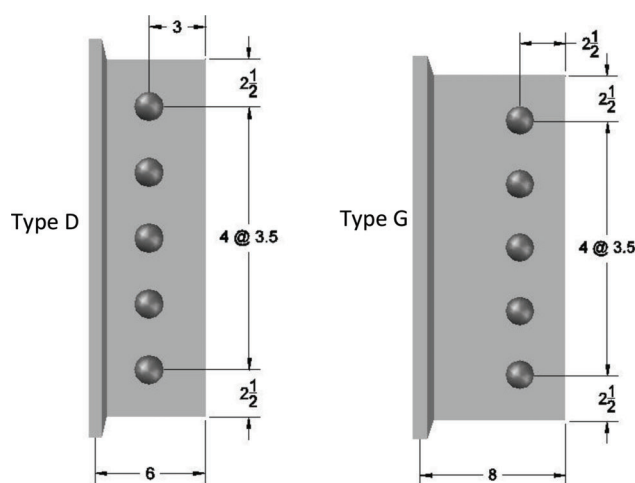
Figure 6.34 Rendering of connection angles used by Cousins *et al.* (1998).

replacement angles and monitored, revealing that the thinner angle (Type D) was more susceptible to fatigue cracking than the thicker angle (Type G) with the longer leg dimension. Figure 6.34 shows the two angles used. The Type D angle was a L6 x 6 x 3/8 inch and the Type G was a L8 x 6 x 1/2 inch. This suggests that when increasing the leg dimensions is possible, it may improve performance more than simply replacing with a thinner angle. However, it may not be feasible to replace angles with ones having longer leg dimensions since it would require new holes, or a slight side shift of the connected element to reuse existing fastener holes, in the floorbeam or girder web plates. Typically, new holes would not be a problem, but this should be checked by a qualified engineer. Paasch and DePiero (1999) found that increasing the angle leg from 4 inches to 6 inches (i.e., increasing the gage length on the outstanding angle leg), reduced the stress range in the angle by 40 percent.

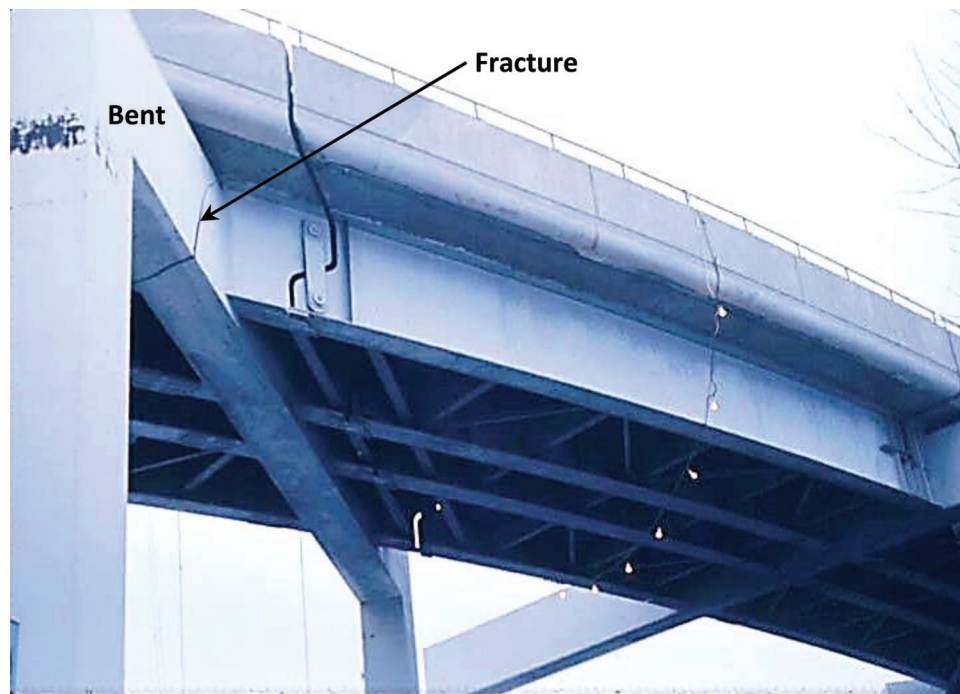
Figure 6.35 Dan Ryan Expressway with fractured cross girder.

In 1978 two bridges were found to have fatigue cracks and brittle fractures emanating from some of the cross girder web penetrations. The first was the Dan Ryan Expressway in Chicago, IL. Three bents were found to have fatigue cracks that led to brittle fracture. Figure 6.35 shows a picture of one of the fractured bents. Fractographic analysis revealed that the cracks initiated as fatigue at the partially welded junction of the plate girder flange tips to the cross girder (bent) side plates. Paint was also observed on the interior surface near the crack, suggesting poor fabrication of the detail

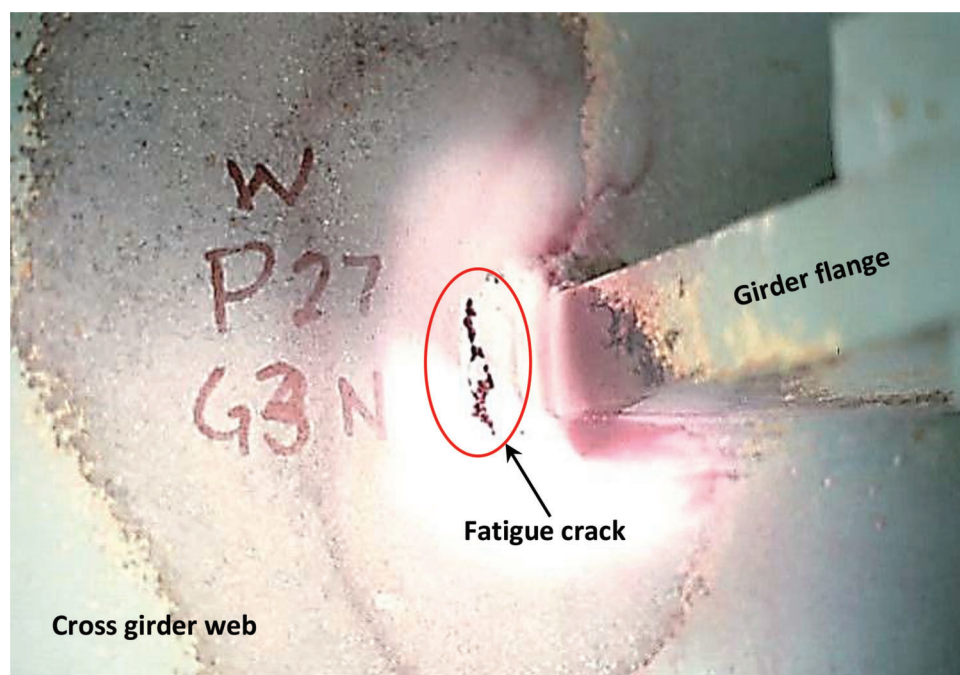
Figure 6.36 Fatigue crack enhanced with PT at girder flange tip and cross girder web.

fatigue cracks were located in at least one girder flange tip in each pier cap. An example of one of the cracks enhanced with dye penetrant is shown in Figure 6.36. The cracks consistently developed at the weld toes on the flange tip-to-cross girder web welds. The bridge had only been in service for two years in 1978 with a “relatively modest level of average daily truck traffic” (Fisher, 1978).

- a. If no cracks are identified, the drilled holes should be centered over the flange tip weld toes.
 - b. If a crack is located at the flange tip weld toe that has not extended into the web plate yet (like in Figure 6.36), then center the drilled holes over the weld toe and proceed to saw cut between them, as described in step 3.

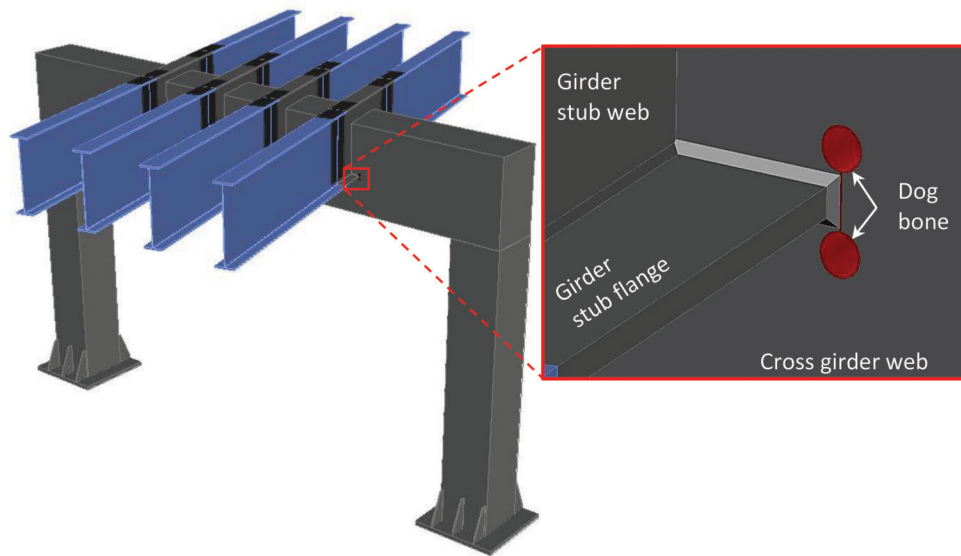
Figure 6.37 Cross girder structure with dog bone retrofit at the web penetration (deck removed for clarity).

cross girder web plate from subsequent fatigue crack growth or even fracture. Figure 6.37 illustrates a typical dog bone retrofit installed at a web penetration detail. Notice the two drilled holes highlighted in red that isolate the girder stub flange tip, which are connected by a vertical cut in the cross girder web plate. The alignment of the drilled holes should be such that the cut is approximately centered at the holes while cutting through the weld toe at the very tip of the flange. This retrofit should be installed at any web penetration detail located within a tension or reversal stress range area.
